UNITED STATES ENVIRONMENTAL PROTECTION AGENCY  
REGION 4  
ATLANTA FEDERAL CENTER  
61 FORSYTH STREET  
ATLANTA, GEORGIA 30303-8960

SUBJ: Opportunity to Show Cause  
Resource Conservation and Recovery Act (RCRA) Compliance Evaluation Inspection (CEI)  
Ascend Performance Materials LLC  
EPA ID Number: ALD006320774

**COMPLIANCE EVALUATION INSPECTION PHOTOGRAPHS**

**OCTOBER 18-19, 2016**

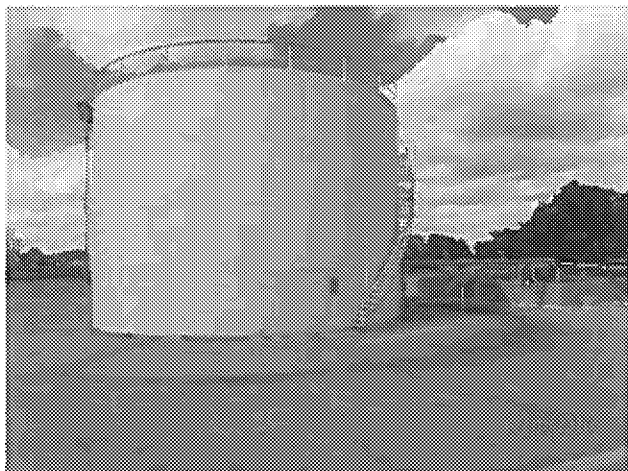
Picture 1 – PN Hazardous Waste Storage Tank

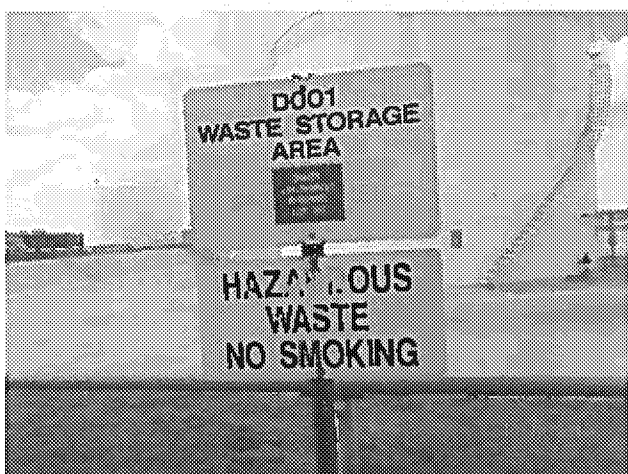
Picture 2 - PN Hazardous Waste Storage Tank

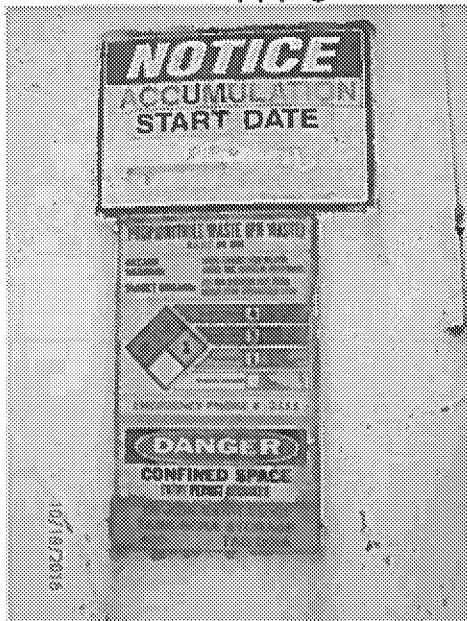
Hazardous waste tank signage was visible in the front of the tank only (Pictures 18, 20). The facility also tracked the start accumulation date on the signage. It was explained that 6% capacity in the tank was considered one railcar. At the time of the inspection, the tank had been fully pumped out on October 10, 2016.

Picture 18 - PN waste tank sign and pump out date

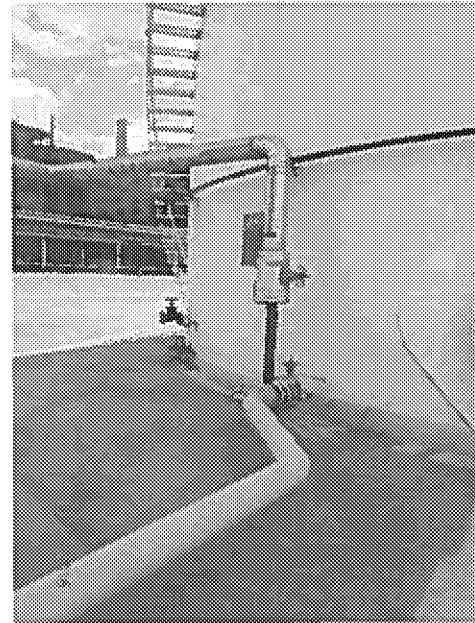
Picture 19 - PN waste tank direct piping

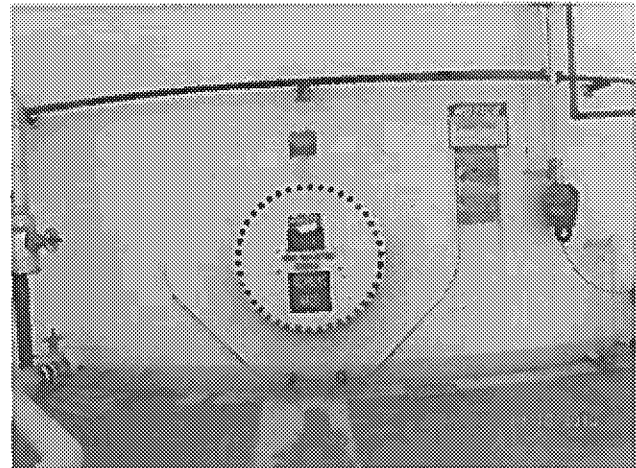
Picture 20 - PN waste tank signs and pump out date

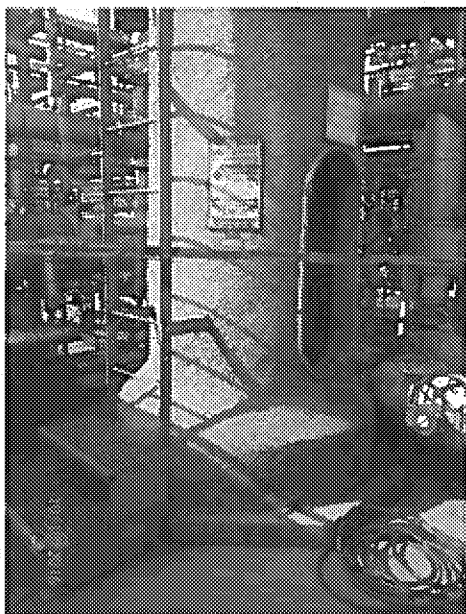
The inspectors followed the hazardous waste piping back to the point of generation, which is the PN refiner tails column (Pictures 21-34). At the time of the inspection, the area was closed for maintenance, but the inspectors were allowed to examine the hazardous waste piping and connections. A LDAR tag was tucked into the insulation around one valve (Picture 25, 27-29), and a valve directly overhead did not have a LDAR tag at all (Picture 26).

Picture 21 – PN Refiner Tails column

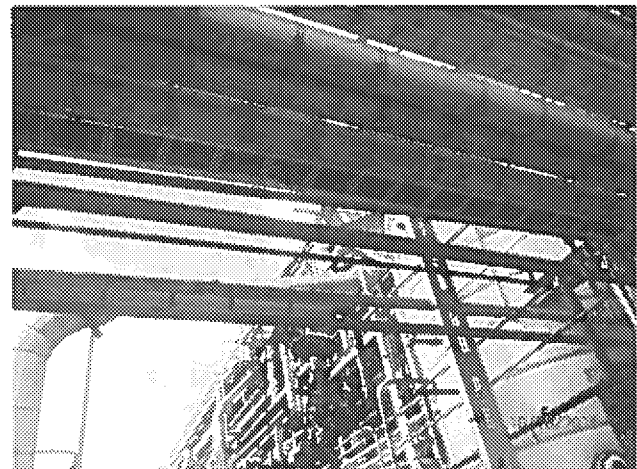
Picture 31 - PN Refiner Tails insulated piping labeled

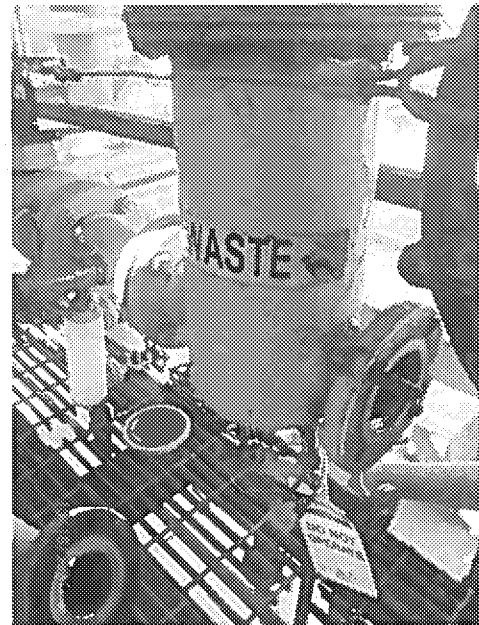
Picture 39 - Railcar unloading piping disconnected for extraction tank hose

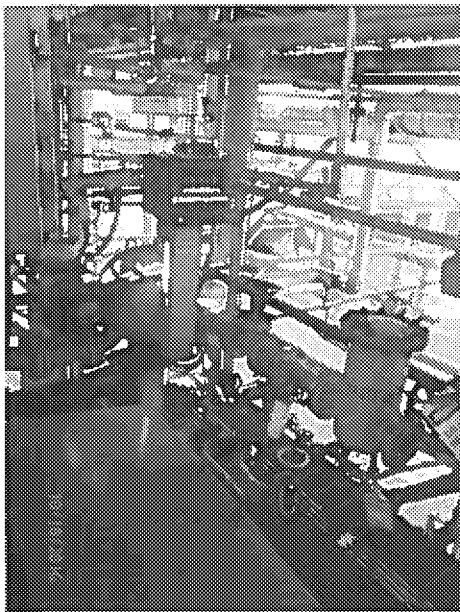
Picture 37 - Railcar unloading and extraction tank piping

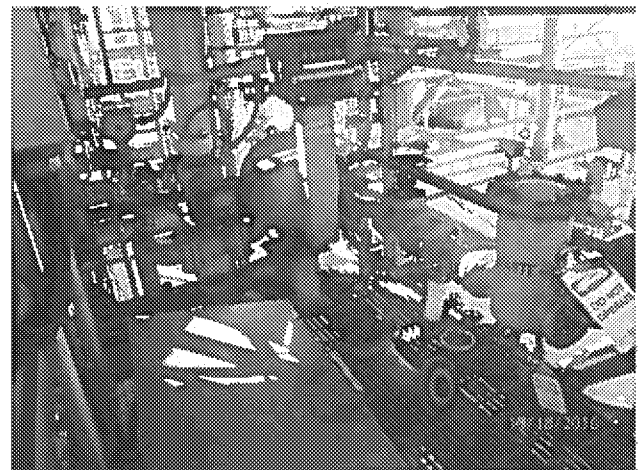
Picture 40 - Railcar unloading and extraction tank piping

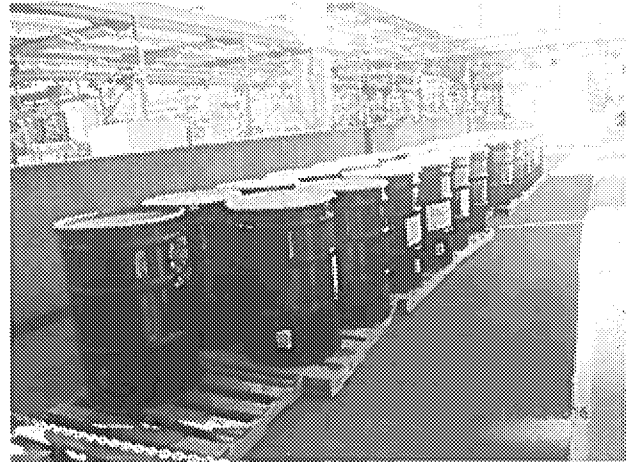
The third section contained 26 55-gallon drums of non-hazardous EHD Package Waste E69I43 and a 55-gallon drum of diesel fuel cleanup (Pictures 48, 51-52). The drums were observed closed and labeled.

Picture 48 - HWSA non-hazardous drum storage

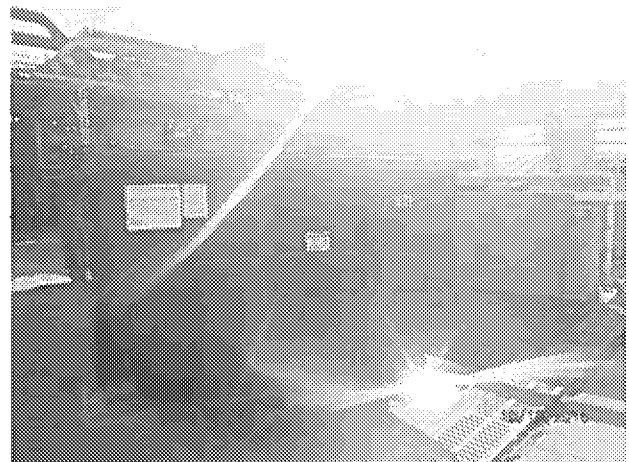
Picture 49 - HWSA hazardous roll-off storage

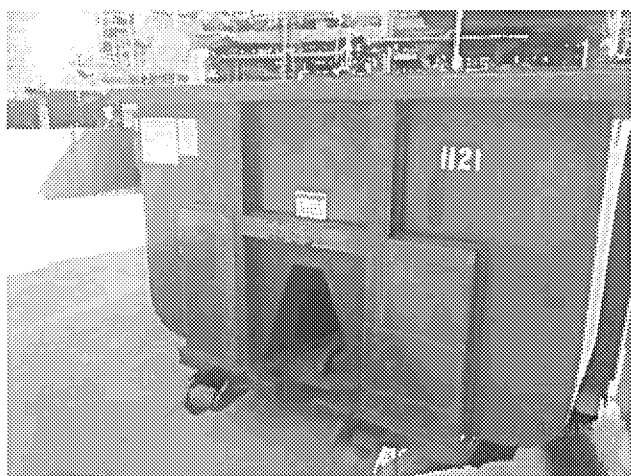
Picture 50 - HWSA hazardous roll-off storage

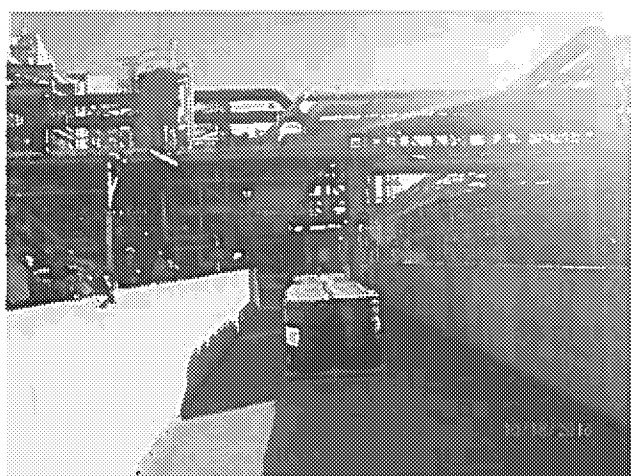
Picture 51 - HWSA non-hazardous drum storage

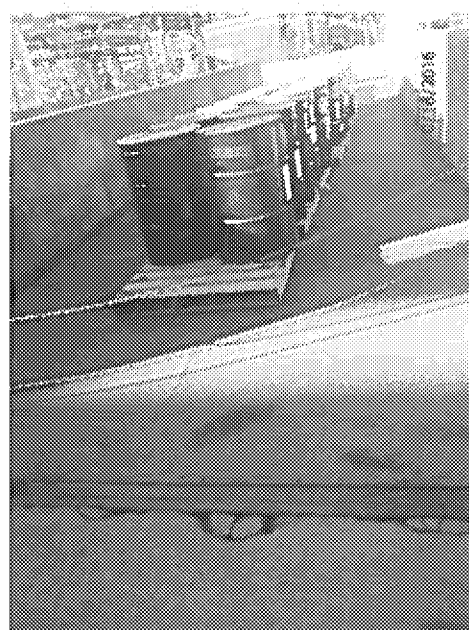
The second section contained 27 55-gallon drums of Edge Strips AG6844, a 55-gallon drum of aerosol cans and a 55-gallon drum of diesel fuel with water with the facility waste handling information sticker and a hazardous waste label (Pictures 47, 53-54). The inspectors observed that the drums were closed, the hazardous waste labels contained the facility information, the start accumulation date but did not have the EPA Waste Codes.

Picture 54 - HWSA hazardous drum storage

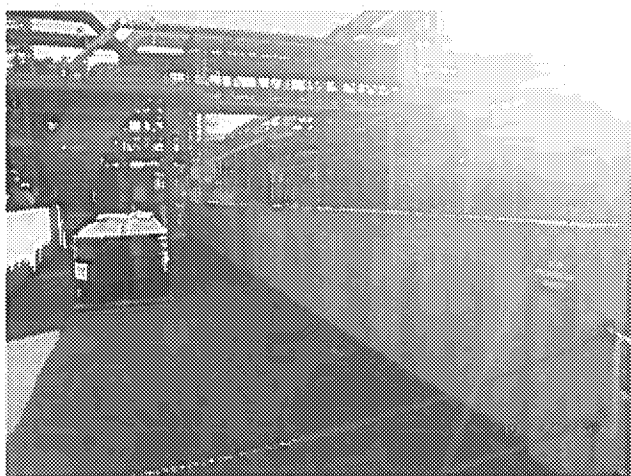
Picture 52 - HWSA non-hazardous drum storage

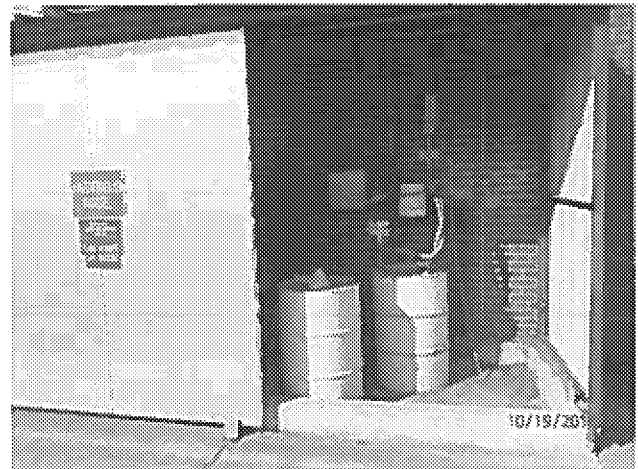
Picture 59 -- Lab Extraction waste and GC vials SAAs

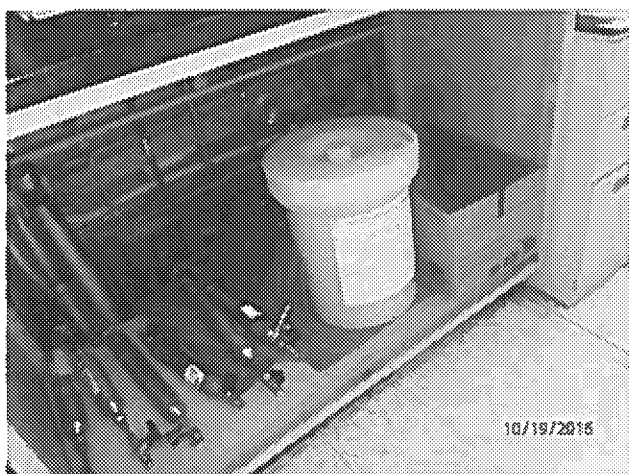
During the lab walk through the inspectors observed two 5-gallon containers for the collection of the used GC vials (Pictures 61-62), a black 55-gallon drum of used syringes and needles in the chemical storage room (Picture 63) and eleven used sharps containers ranging in size from 3.3 quarts to 6.9 quarts (Picture 64). All of these wastes were hazardous wastes. The inspectors observed the drums to be labeled as hazardous waste, but the sharps containers were not labeled. The Ascend personnel explained that the used sharps containers were emptied into the sharps drum because the materials handled in the lab were considered hazardous waste. The inspectors stated that the used sharps containers should be labeled as hazardous waste. In addition, the containers were not consistently kept closed. The Ascend personnel proposed to use the larger container to collect the used sharps in the future.

Picture 61 – Lab used GC vial SAA

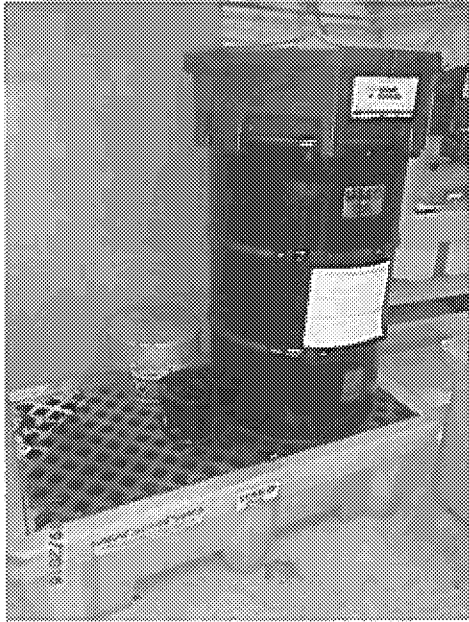
Picture 66 -- Central Maintenance Shop used oil drum

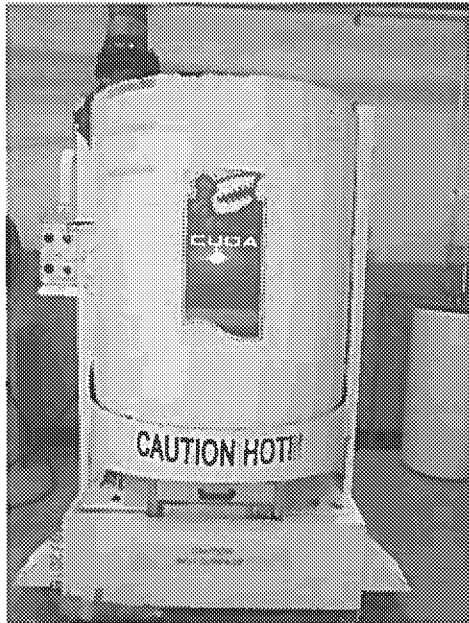
A non-hazardous waste parts washer (Picture 67) was observed near the back of the area. The unit was not running during the inspection, but Mr. Tim Looney, Pump Shop Mechanic, stated that the rinse water from the parts washer were pumped into drums and taken to the HWSA. On the side of the parts washer was an oil skimmer. The oil from the skimmer is discarded as used oil, but the skimmer was not labeled as “Used Oil” (Picture 68).

Picture 67 -- Central Maintenance Shop parts washer

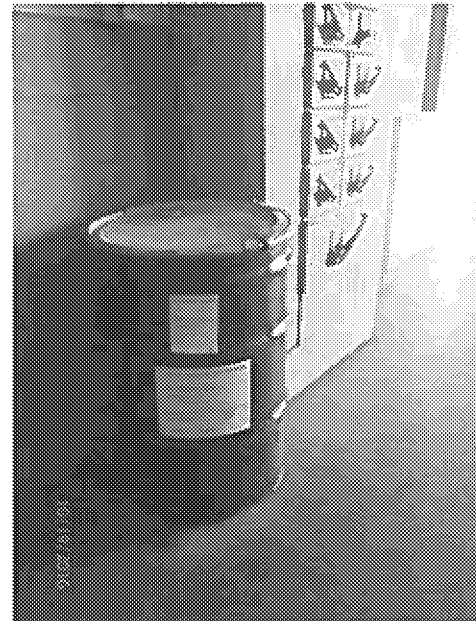
Two additional SAAs were observed in the shop. A black 55-gallon drum of used aerosol cans (Picture 69) and a black 55-gallon drum of crushed bulbs with a bulb crushing unit on top (Pictures 70-71) were observed closed and labeled.

Picture 69 -- Central Maintenance Shop used aerosol drum

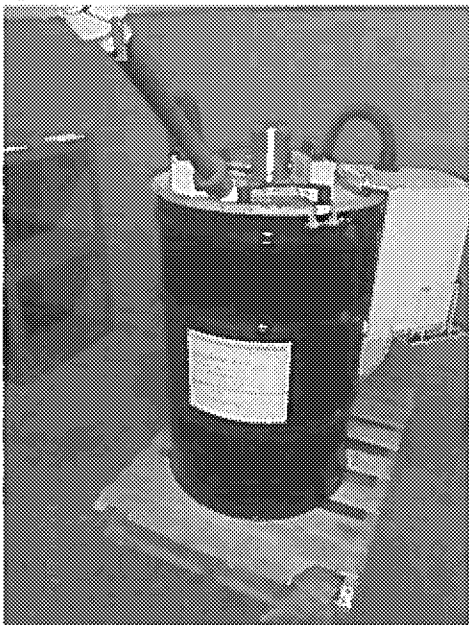
Picture 70 – Central Maintenance Shop bulb crusher

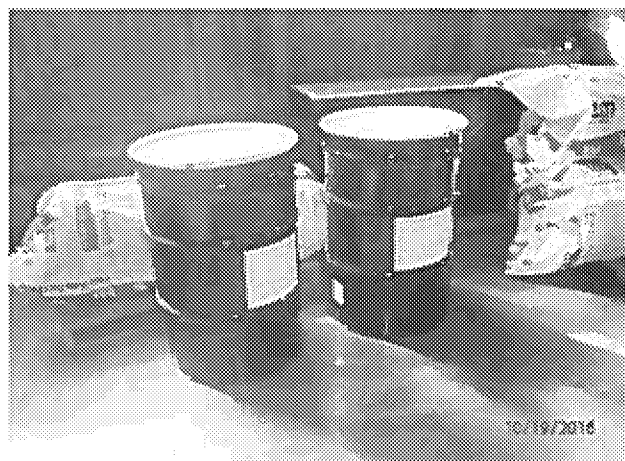
Picture 74 – No. 2 Warehouse UW storage – PCB drums

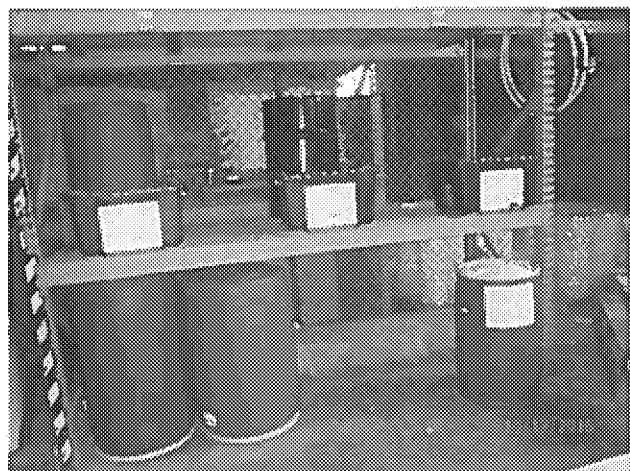
Picture 72 – No. 2 Warehouse UW storage

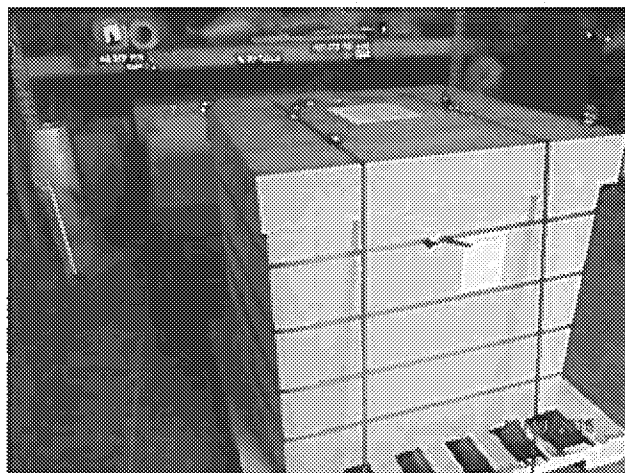
Picture 75 – No. 2 Warehouse UW storage damaged batteries

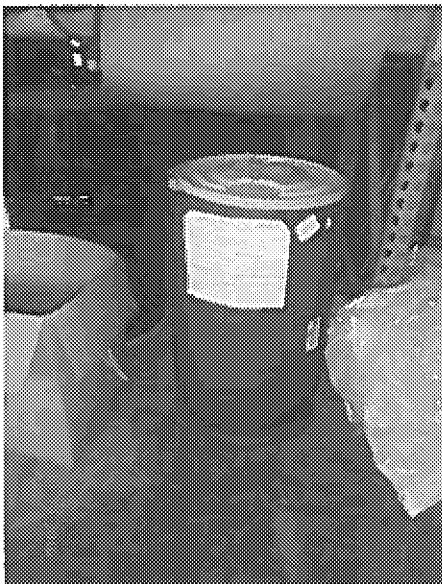
Picture 78 -- No. 2 Warehouse UW storage - misc. mercury bulbs
